**Technical Service
BULLETIN**

**UNINTENDED POWER REAR WINDOW
ACTIVATION**

'99 – '01 4Runner

**ELECTRICAL
EL005-01**

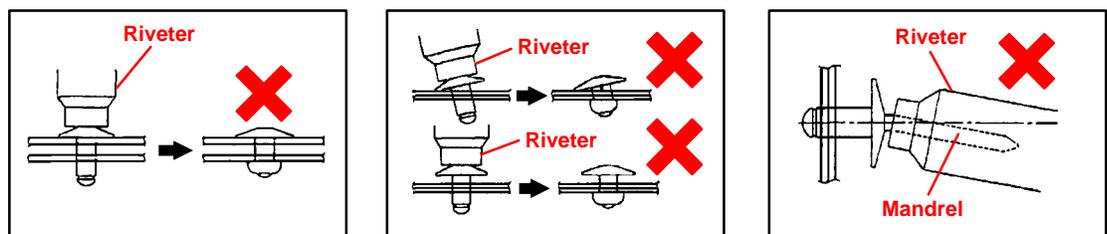
IMPROPERLY INSERTED RIVETS

To ensure proper water intrusion protection, make sure that the rivet is properly inserted into the securing hole before affixing it. Refer to the warning illustrations below.

- C. Remove the Back Door ECU.
- D. Install the new Back Door ECU.
 - Re-secure the new ECU with 2 new Rivets (P/N 90269–05035).
