# THROWOUT / RELEASE BEARING & PILOT SHAFT ISSUES

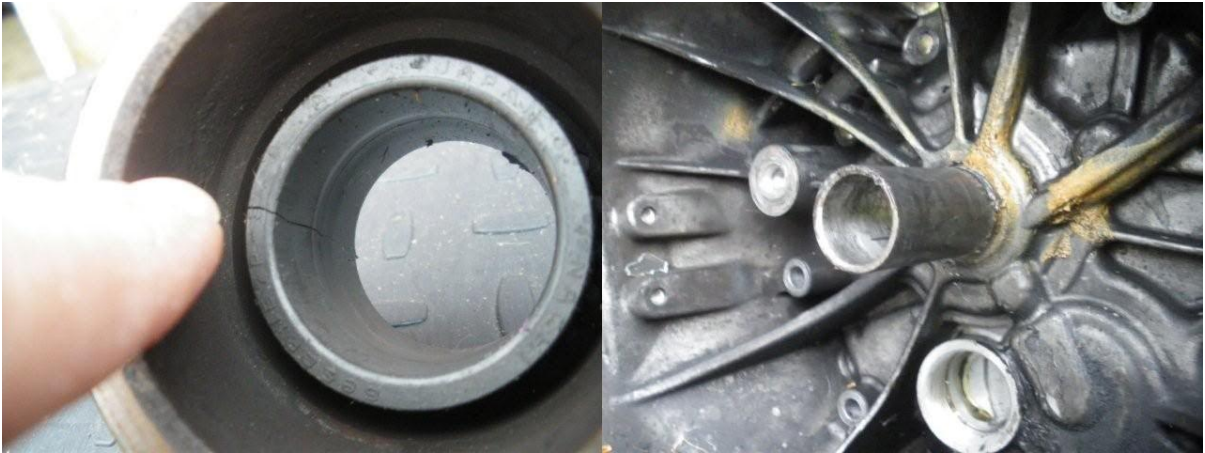
**Cracked Throwout / Release Bearing, Pilot Shaft + Toyota spray – on Lithium Grease on a Toyota Tacoma; not an appropriate fix done by many dealers, which may even contaminate the Clutch Disk surface and Flywheel.**

The only proper repair entails replacing the Bell Housing because the Pilot Shaft (unlike in earlier Tacomas with 5 - speed Manual Transmissions) is a non - serviceable or replaceable component. If you can get a new transmission, you'll be better off and the dealers will usually prefer to replace the transmission based on the time and difficulty of a rebuild. Theoretically, if Toyota made replacement Throwout / Release Bearings with different inner rings or replaceable Pilot Shafts, the repair would be far less costly. Many times, a technician will go through all the effort to give you a new Throwout / Release Bearing, Pressure Plate and Clutch Disc, Slave Cylinder, or various combinations of those components only to find you back in the shop within a couple of weeks or less. Worse, they might replace the Flywheel the second time around, which results from misdiagnosis of the "chirp."

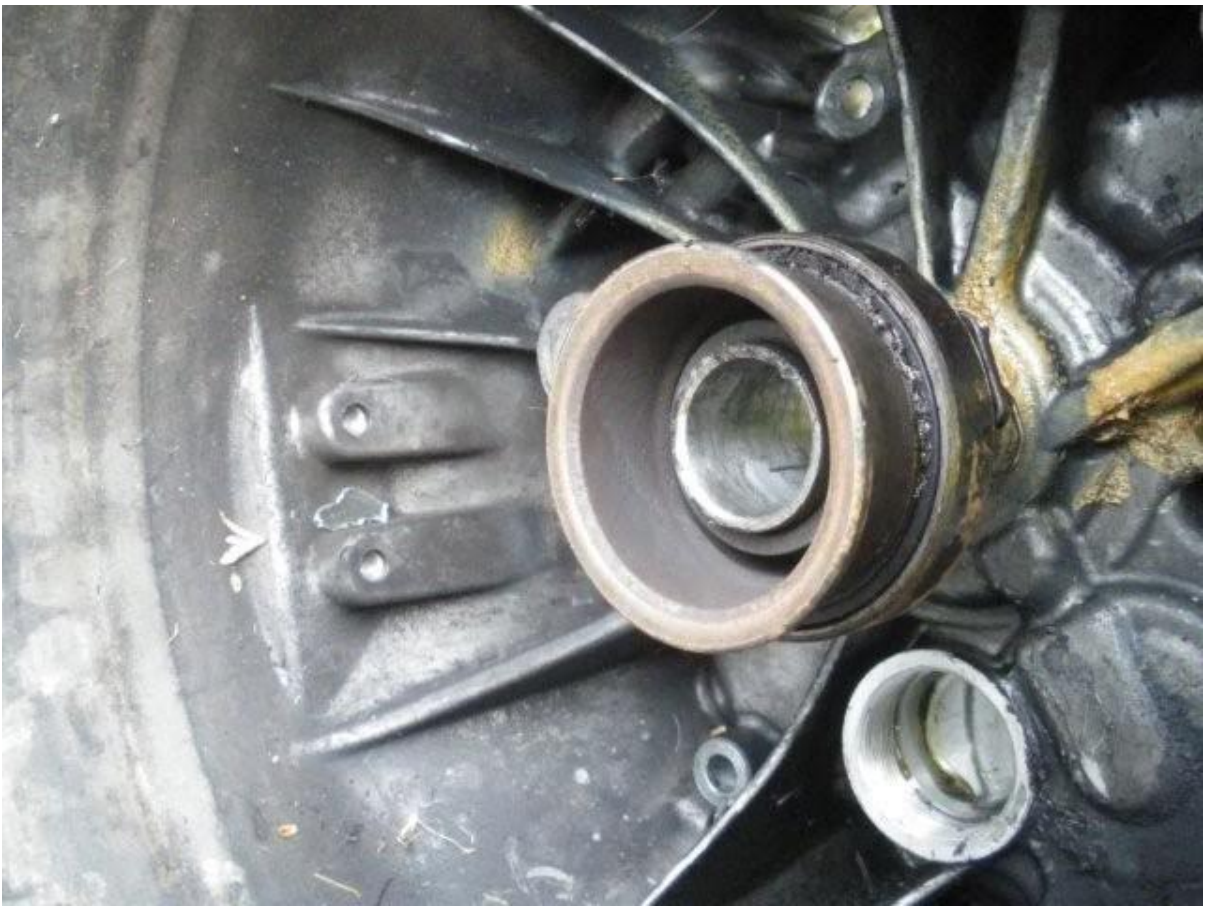
**Throwout / Release Bearing positioned on the Pilot Shaft:**

The Release Bearing is designed to maintain contact with the pressure plate at all times; the outer ring is supposed to spin constantly, while the inner ring maintains a nice tight fit sliding back and forth about an inch or so on the Pilot Shaft. Once the inner ring of the Throwout / Release Bearing cracks or wears and begins to wobble, the Pilot Shaft wears down (or vice versa) - resulting in the "chirping." Depressing the clutch pedal slightly allows the fingers of the Fork to stabilize the bearing wobble.

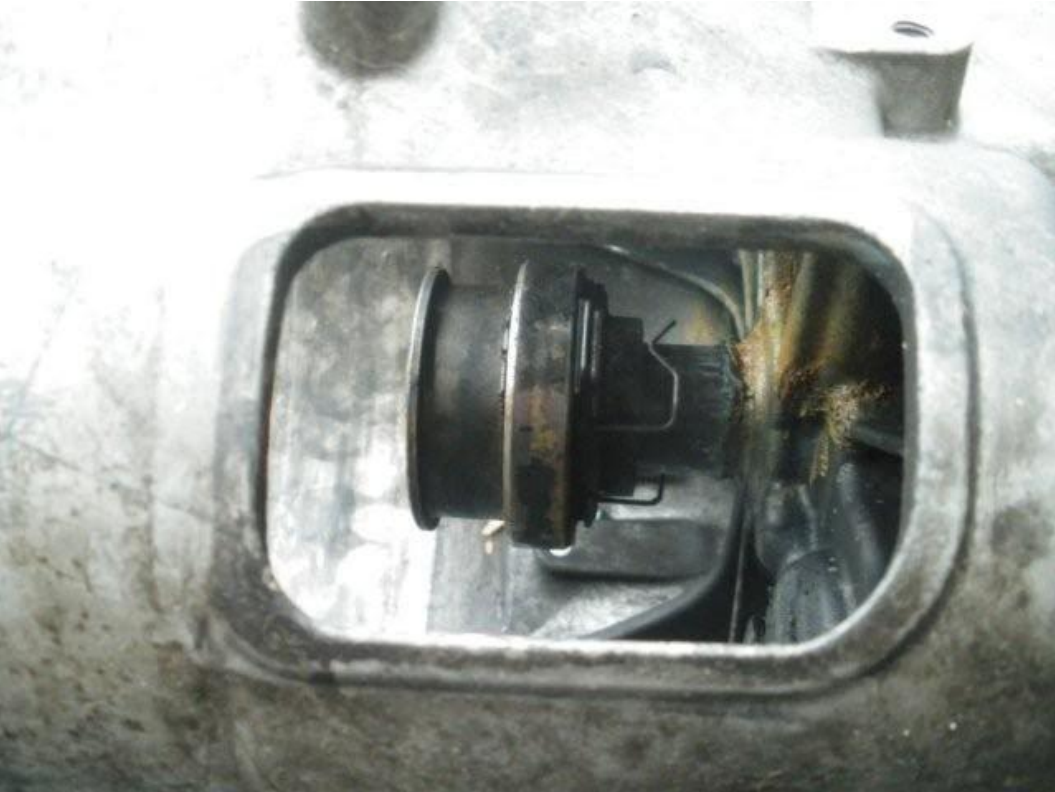
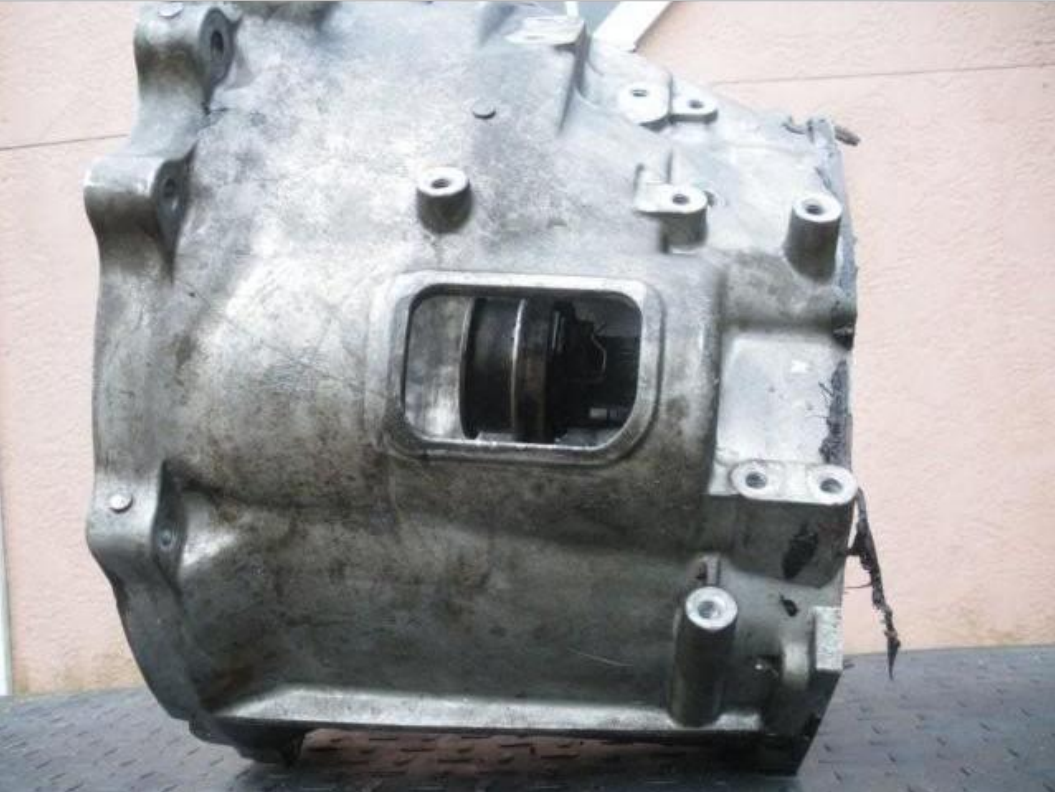
**2 views through the cover plate:**

When viewing the operation of the Throwout / Release Bearing with the engine running and the cover removed (using a flashlight), the technician should be able to visualize a degree of Throwout / Release Bearing wobble. Applying a small amount of pressure to the Slave Cylinder shaft moves the Fork, and stabilizes the Throwout / Release Bearing enough to stop the chirp. It is this observation that leads some technicians to simply tense the Clutch Pedal as a fix (inappropriate). The next step is to drop the transmission and do a detailed inspection of the Pilot Shaft.

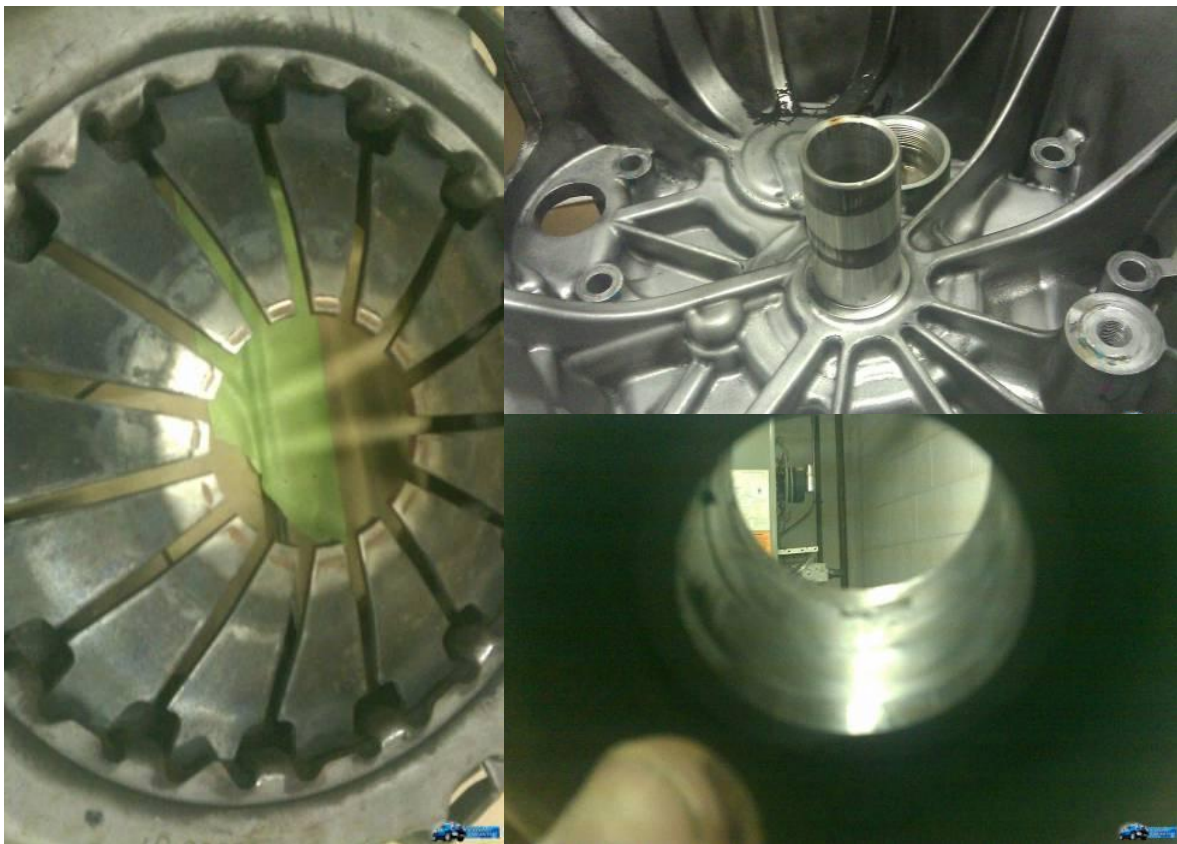
**Damaged Parts from FJ Cruiser (Pressure Plate, Pilot Shaft, Throwout / Release Bearing inner ring):**

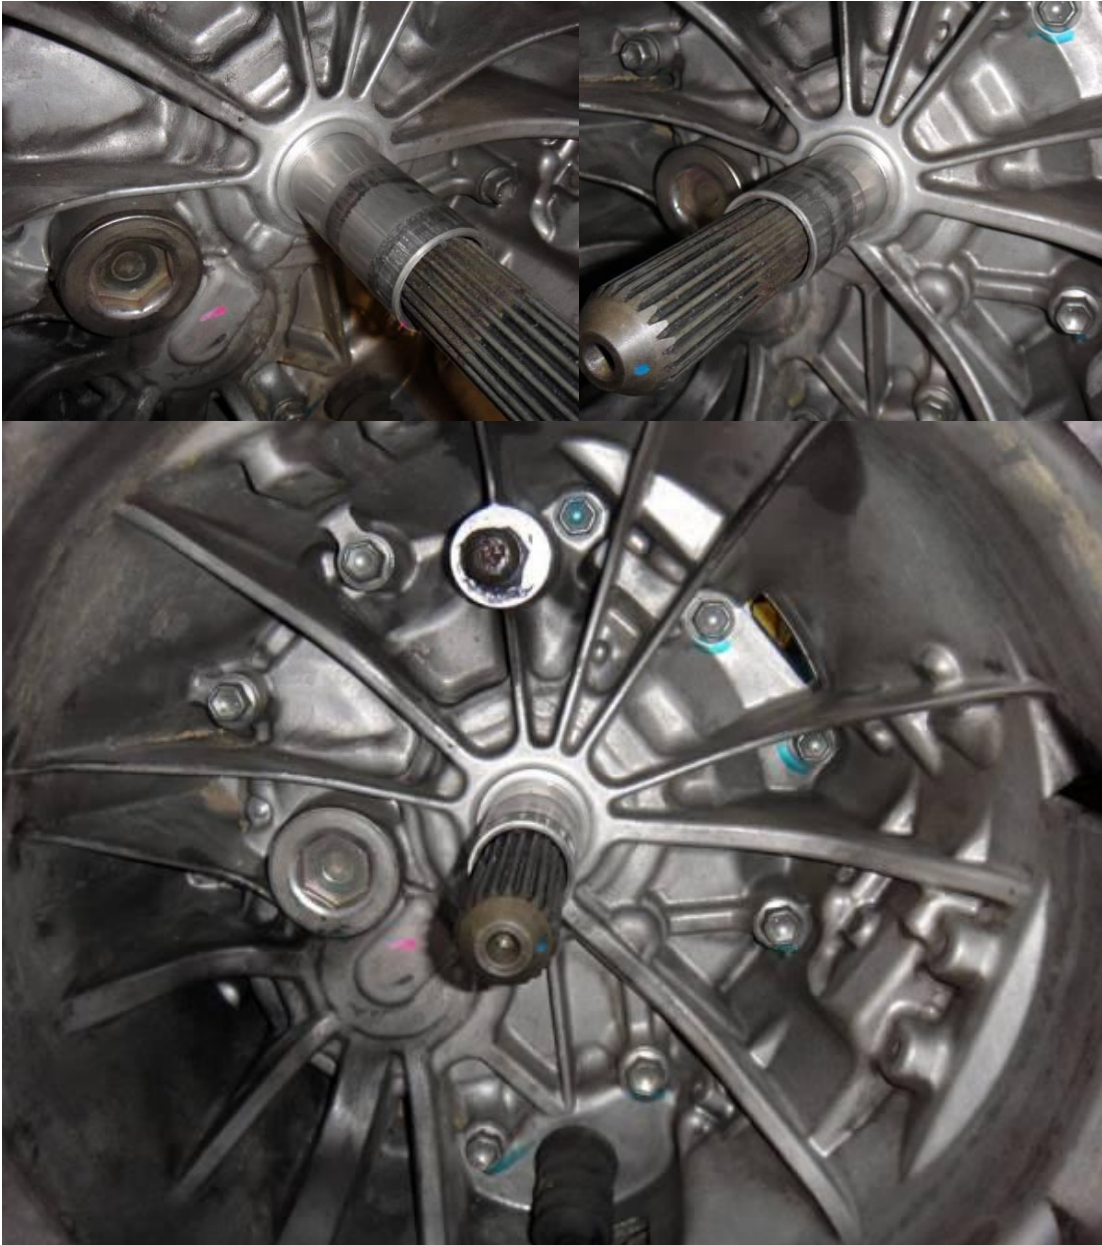
Old Quill (note scoring on shaft) and Housing
