## **Toyota 4-Runner Power Window Master Switch Repair**

This is a repair for an incorrectly wired power window master switch (door panel mounted) for a 1984-1988 Toyota 4-Runner. The door panel on the driver's side door has to be removed so you can unplug the old switch.

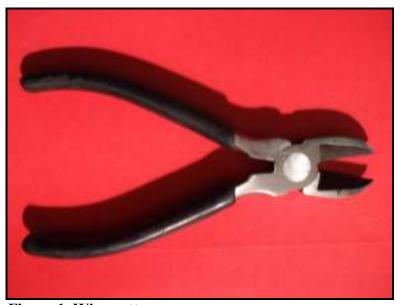
Figure 1. Wire cutters.

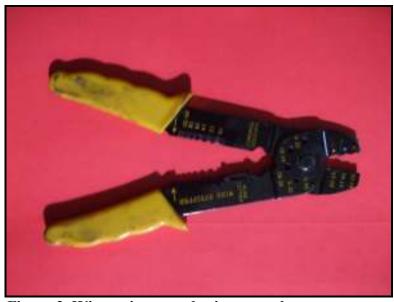
Figure 2. Wire stripper and crimper tool.

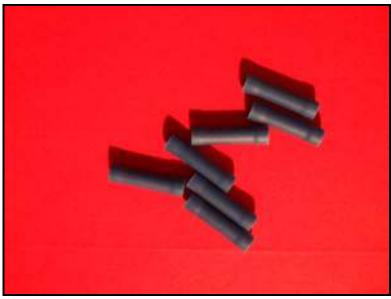
Figure 3. Butt connectors.

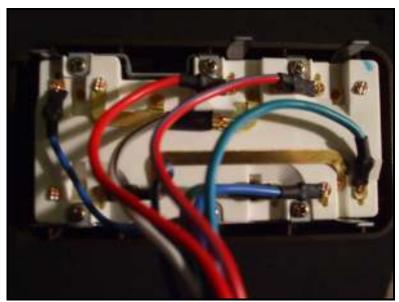
Wires between the switch (Figure 4) and plug the (Figure 5) need to be cut in the middle and rejoined with butt connectors. Wires from the switch need to be connected to the proper wire on the plug (Figure 6). Starting at the top wire on the back left side of the switch the wires are numbered: 6 blue wire, 8 red wire, 4 white and black wire (below 8), and 5 red and blue wire. The bottom row wires (left to right) are numbered: 7 blue and black (can be seen between two red wires), 3 green wire (mostly hidden below 1 blue wire), 1 blue wire, and 2 green wire and light blue wire (see Figure 6). Double check with your old switch to make sure the wiring diagram below (Figure 6) is correct for your switch. Old and new switches need to be wired the same. An ohm meter is handy to check that your connections are good.

Figure 4. Back side of power switch.

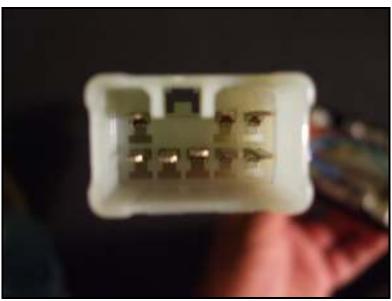
Figure 5. Interior view of switch plug.

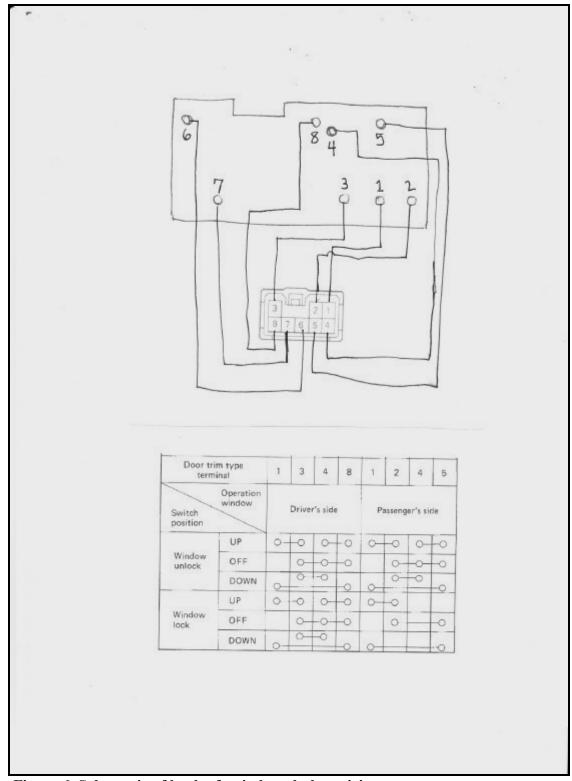
The wiring sequence for the plug (left to right) (see Figure 6) is: Top row: 3, 2, 1. Bottom row is 8, 7, 6, 5, 4.

Wiring switch to plug: wire 1 on switch goes to lug position 1 on plug; wire 2 on switch goes to lug position 2 on plug; wire 3 on switch goes to lug position 3 on plug; and so forth. Wire colors of course will be mismatched. Finished product (Figure 7).

Figure 6. Schematic of back of switch and plug wiring.

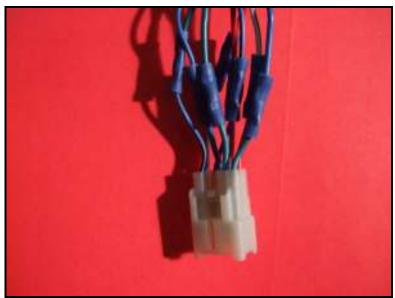
Figure 7. Finished product.
